Summary Sep04

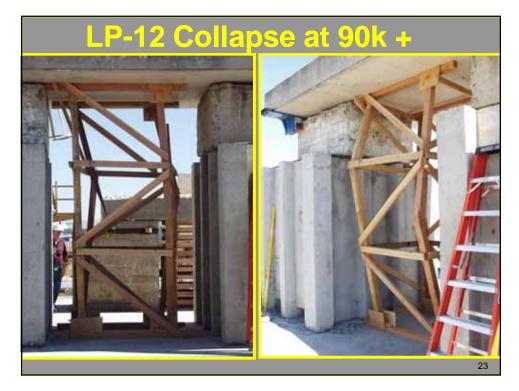
- One can observe significant cupping of 2x4 Wedges at 2x Design Load
- Laced Post System as constructed has members and connections that are sufficient to brace system to resist 3 times Design Load
- Failure often occurs in posts w/knots that are near joints
- There is not much lateral strength or stuffiness

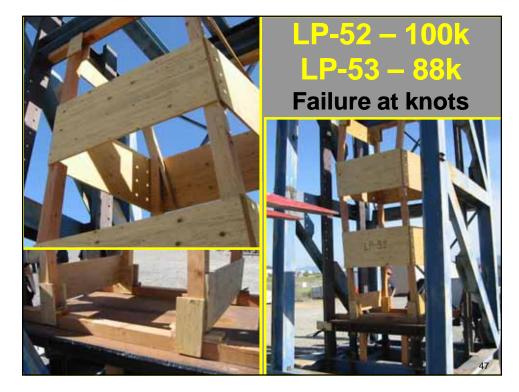
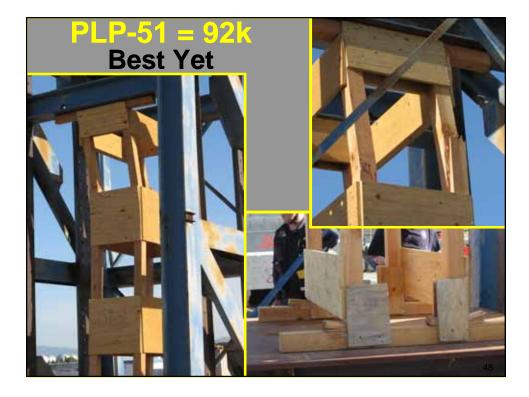
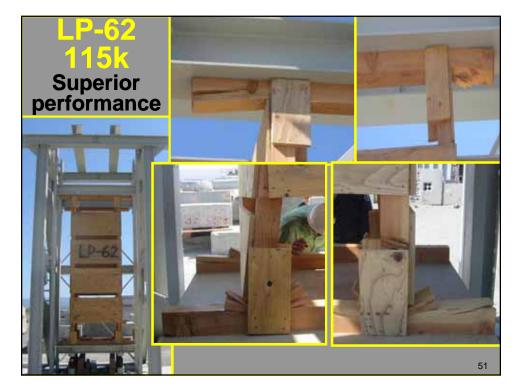
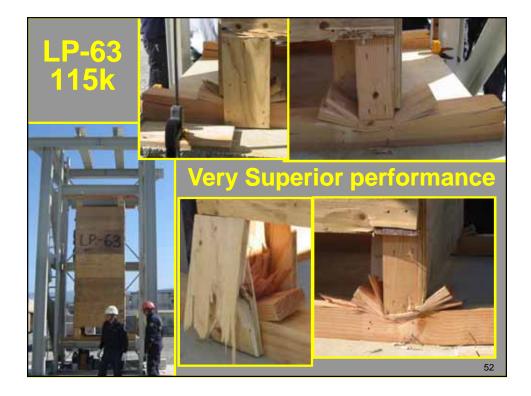
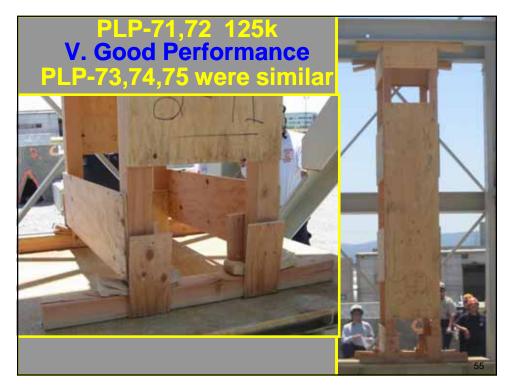
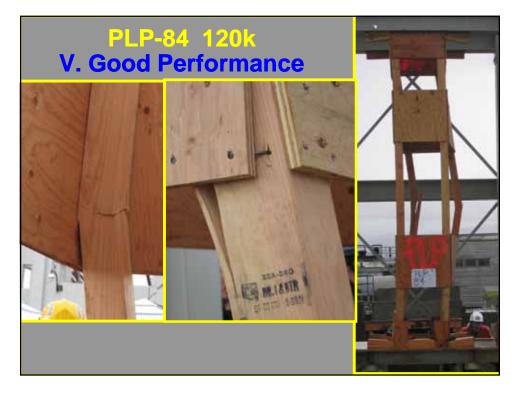
Sum o	of 12 L	.aced	Post Tests (w/ Diag 2x)	
Shore	Lacing	Failure	Comment	
LP-1	2x4	100k	Failed at post knots	
LP-2	2x4	90k+	Total system failure - Poor	
LP-11	2x4	90k+	Failed at post knots	
LP-12	2x4	90k+	Failed at post knots	
LP-13	2x4	N/A	Lat. load test at 38k only	
LP-21	2x6	110k+	Good performance	
LP-22	2x6	90k+	Posts were split prior to test. Failed at many joints	
LP-24	2x4	100k+	2 cycles of 2" lateral w/38k then load to failure. V.good	
LP-31	2x4	103k	New Loading Sys=accurate	
LP-41, 61	2x4	103k	Similar to LP-31	
LP-51	2x4	90k	New load frame w/no load averaging between posts 62

Sum of 12 L. Post Tests – 2x Diag
•	One can observe Significant cupping of 2x4 Wedges at 2x Working Load – Splitting of Headers may occur at 2x to 3x Working Load, depending on slope & direction of grain
	4x4 - Laced Post Systems consistently resist 3 times Working Load
	Failure often occurs in posts w/knots that are near joints
•	The Direction of the Diagonal Braces may not have a significant effect.
	The use of 2x6 Diagonals with 4x4 posts may not produce increased strength, depending on splitting of the posts due to nail concentration
	Total deflection is about 1.5 to 2" at failure
